February 29, 2008

NATIONAL FIRE EQUIPMENT SYSTEM CACHE MEMORANDUM NO. 08-3

Subject: Kochek Hose Clamp Retrofit

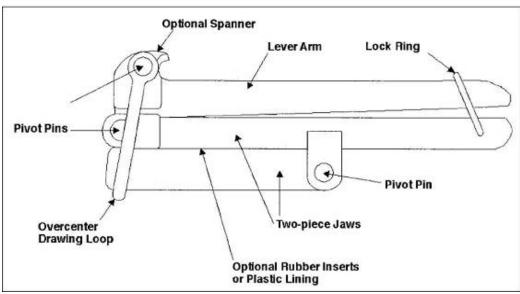
Figure 1

SDTDC investigated in detail the cause of the failure and explored possible retrofit options. The Kochek hose clamp is constructed with three pivot pins (see Figure 1). SDTDC found if pivot pin retention is not sufficient, the pivot pins hinging the two-piece jaws can be easily pushed out.

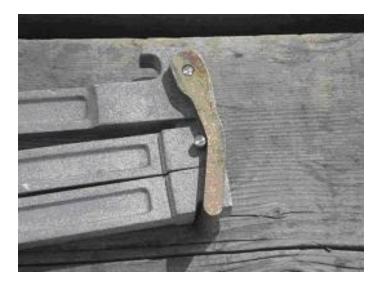
Figure 2

Most field failures are caused by the displacement of the pivot pin from the center arm of the two piece jaws. In the worst case scenario the pin completely separates from the assembly and the clamp falls apart. More often however, the displaced pin causes an impingement with the brass over-center drawing loop. When the handle is pushed down to shutoff water flow in the fire hose, the drawing loop presses against the pin causing the drawing loop to distort or break (see Figure 2)
