Rapid Lesson Sharing

Event Type: Cougar Creek
Blackhawk Bucket Operations

Date: August 26, 2015

Location: Pacific Northwest Region

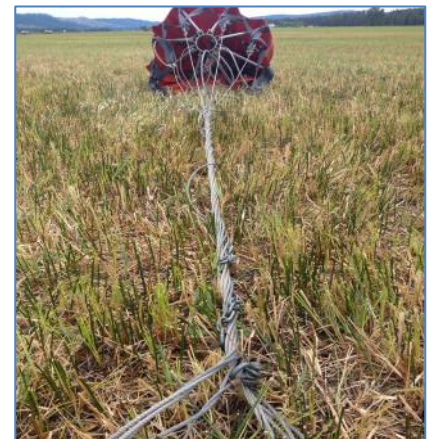
Problem 1: Twisted or Hung-Up Guy Lines/Longline

The Bambi bucket has its own flight profile—it wants to spin. However, due to their lack of visibility from the aircraft, the crew may not be able to visually see just how spun-up the longline and bucket is becoming.

The longline almost certainly needs to be 80% unspun before the bucket enters the water. Therefore, the speed of the descending bucket into the dip site can directly affect the condition or position of the guy lines and longline as it is being pulled out. Furthermore, the weight of the water in the bucket will compound the effects of the twisted or hung up guy lines by not allowing them to naturally unspin or come free of any hang-ups.

Problem 1: Example of twisted guy lines after the Bambi bucket spins in flight.

Corrective Action 1

Slow the descent into the dip site and allow the guy lines to be completely unspun prior to allowing the bucket to fully submerge.

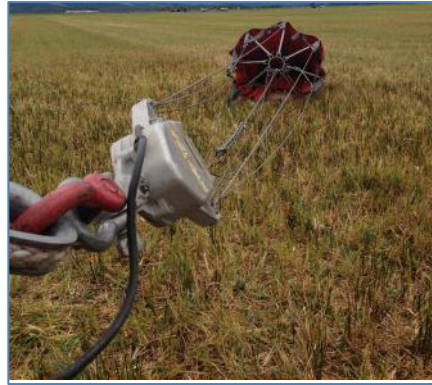
Corrective Action 1:
Example of unspun guy lines needed prior to entering the dip site.

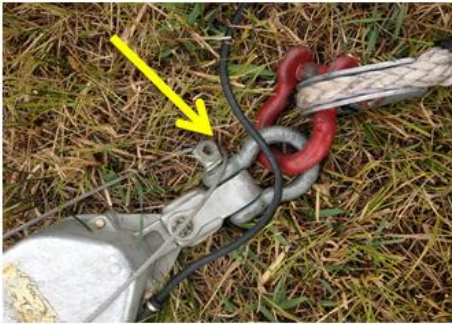
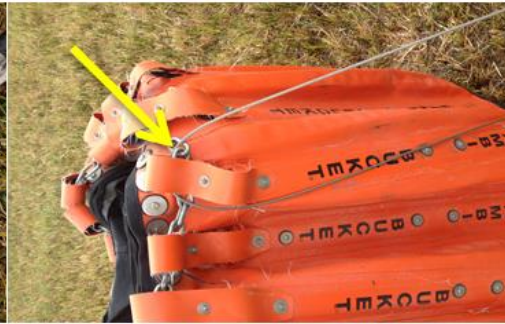
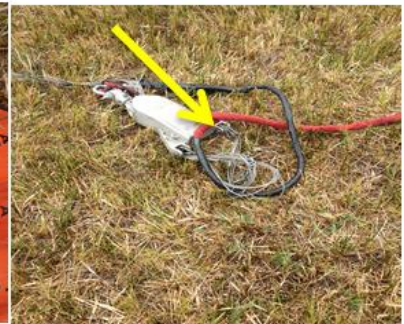
This causes the pilot to then use the control head of the bucket to sink the bucket. (This also causes the pilot to then "chase" the bucket across the dip site, which, in turn, can cause other severe issues.) "When the control head drops below the bucket in the water, there is a greater propensity for the entanglement of the guy wires and the control head to occur," explains Randall.

Examples of how the bucket may become entangled with guy lines when the control head is used to sink the bucket, rather than allowing the weights in the bucket to submerge it. This can cause unnecessary wear to the bucket and guy lines. In some cases, this can only be fixed by setting the helicopter down and manually untangling the guy wires.

Corrective Action 2

Again, a slower descent into the dip site will allow for some of the rotor wash to dissipate and allow for proper alignment of the bucket prior to entering the water. This slower descent also allows for the weights inside the bucket to take affect and sink the bucket naturally.
