USDA Forest Service, Region 5

## AVIATION SAFETY SUMMARY

### SAFETY TOPIC: Clear the Line Before the Drop:

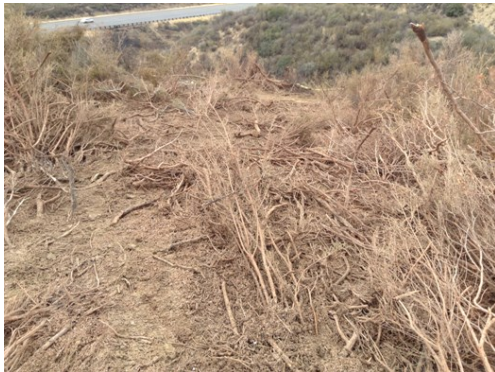
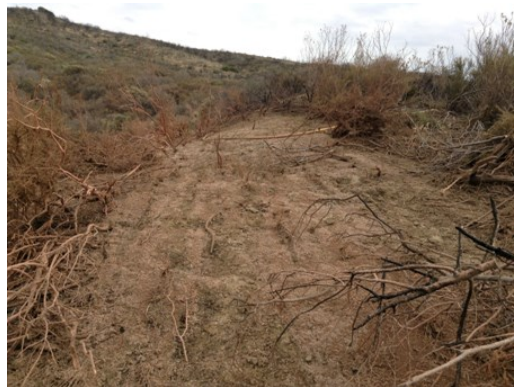
#### SAFECOM 13-0556 :

Narrative: An air tanker made a retardant drop at a height and speed that scrubbed the ground clean to bare mineral soil for a distance of ~300 ft.-400 ft., and 15 ft. wide. Brush, in some places 6 ft. high, was removed or damaged. Eyewitnesses state the plane was between 50 ft.-100 ft. high, and lower than the lead plane. The lead plane also appeared to be no more than 100 ft.-150 ft. high. Two fire fighters only had time to lie down in the drop zone, but not clear it: they were hit by the drop. Thankfully, neither fire fighter was injured. Below are pictures illustrating the force of this drop:

While it appears this line may have been constructed by heavy equipment, it in fact, was the result of a low level retardant drop. The amount of force actually uprooted some vegetation in the path of the drop.

Follow-up: The drop profile was discussed with the pilot, and it was discovered that it was first and only drop on the initial attack fire. The pilot was told the line was clear and thought with the sloping terrain, he was at a good drop height. The pilot took full responsibility for the low drop.

Lessons Learned: Be extra cautious and clear the line a greater distance than normal on initial attack fires as pilots (helicopter and airtankers) are not always familiar with the terrain they will be operating in and may misjudge the drop zone or the drop height.
